**Turnstone**  
Marine Survey LLC

# **REPORT OF THE MARINE SURVEY**

***“My Girl”***

**1999 Stamas 310 Express**

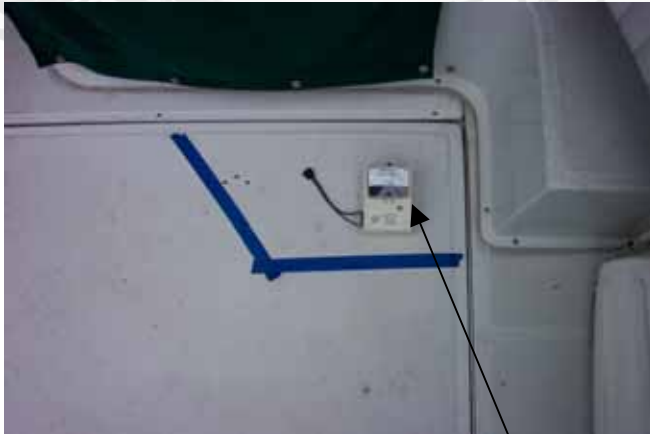
Forward starboard corner of the starboard hatch cover sounded flat. Cracks showed in laminate. Remainder of weather deck sounded solid.

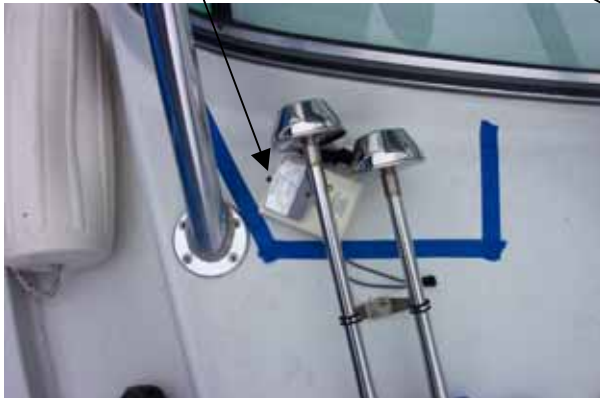
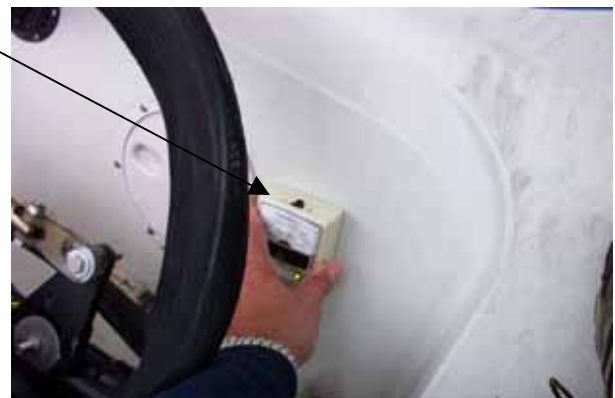
Moisture readings high in same area of hatch cover as above. Moisture readings showed high also around electric horn on foredeck, and on fish/swim platform immediately ahead of outboard motors. (\* Finding B3)

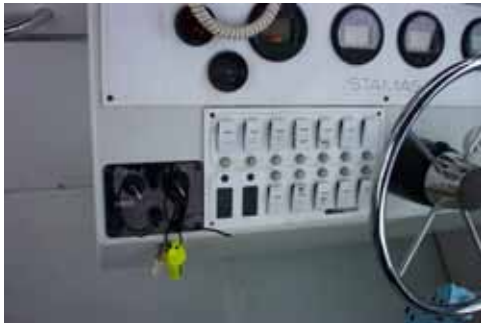
The DC panel is on the helm station. Each switch has a circuit breaker and power indicator light. The helm tips aft to access instruments, wiring and an automotive style fuse panel unlabeled as to function. One of the captive spade connections on this panel is loose and the terminal insulator has slipped off the terminal. (\* Finding B3)

**\*B3:** A captive spade terminal is loose on the fuse block inside helm station. Simple to compress with pliers, reattach and reset yellow insulator over terminal.

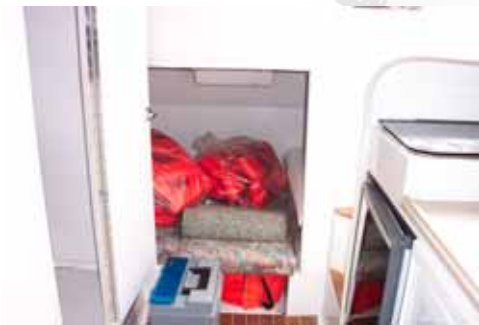
**\*A2: This is a combination of 2 CFR violations that is easily fixed but must be mentioned. The PFDs and throwable life preserver are stowed in bags in the mid cabin berth. This is a violation of CFR 46 Sec 25.25-9a,b and CFR 33 Sec 175.19a;b which states these devices must be readily accessible.**

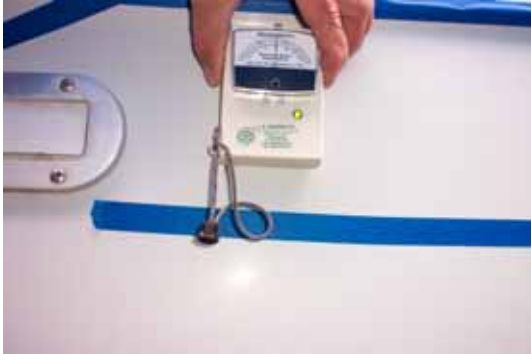
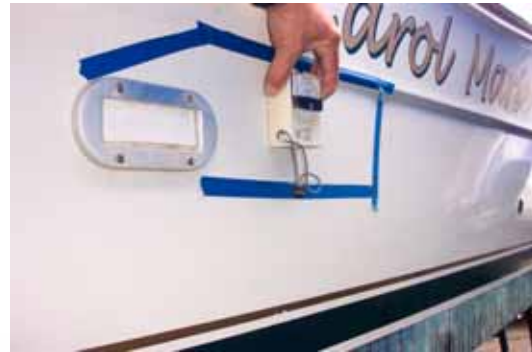
One area forward of the cockpit scupper on starboard side registered high moisture content. (\* Finding B1)

**\*B1:** Area forward of cockpit scupper tested wet. Repair as soon as possible. First remove scupper frame and reseal. Remove and reseal any other deck hardware in the area. Look closely for cracks.

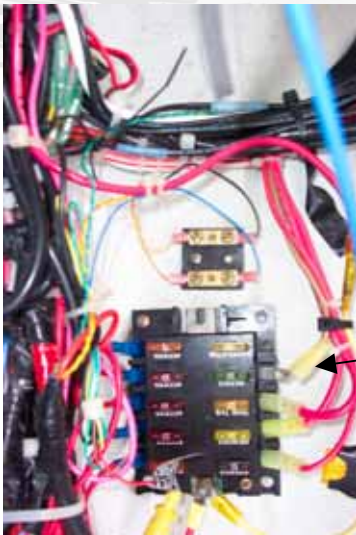
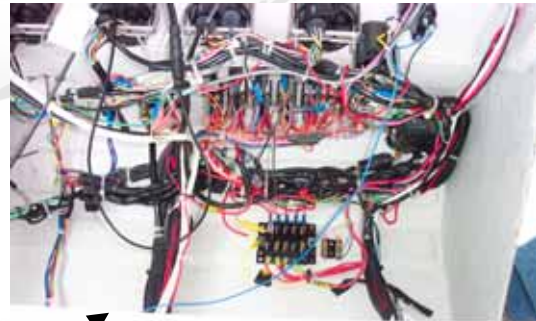
Note clean wiring job and access behind opened helm station.
