**Turnstone**  
Marine Survey LLC

# **REPORT OF THE MARINE SURVEY**

***“My Girl”***

**1999 Stamas 310 Express**

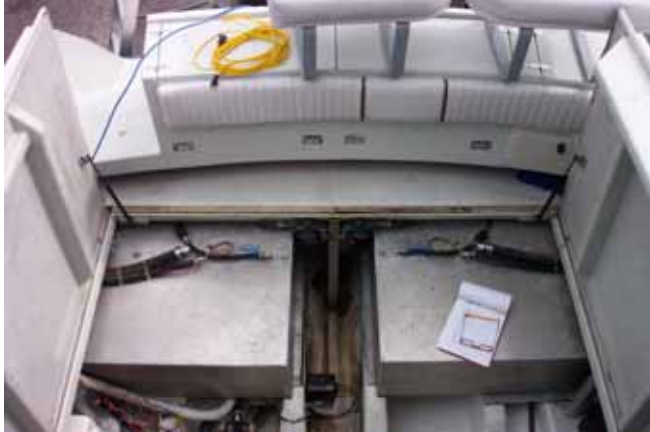
**COCKPIT**

The 10' by 7" cockpit floodlit from bimini frame, has a molded non-skid floor, 2 large (62" by 41.5") hatches, a fish cleaning station with storage drawers, 2 removable seats at transom showing weather damage to vinyl, (\* Finding B2), 1 rear facing seat with storage underneath at bridge deck, and cushioned combing all around. Large scuppers for drainage port and starboard. (Note: The hatch covers should have a way of being secured while open to avoid injury).

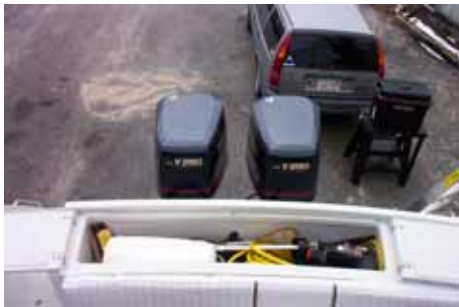
#### FISH BOXES

There is a large fish box, 56" long by 12" wide and 13" deep with scupper drains in the transom.

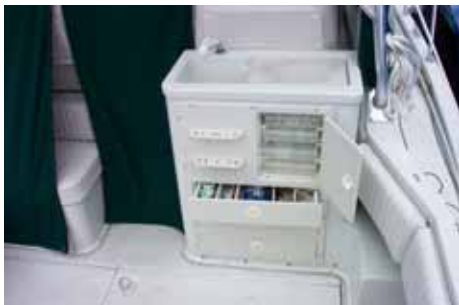
#### OTHER

The fish cleaning station with sink and transom door enhance the fishing ability of the boat.

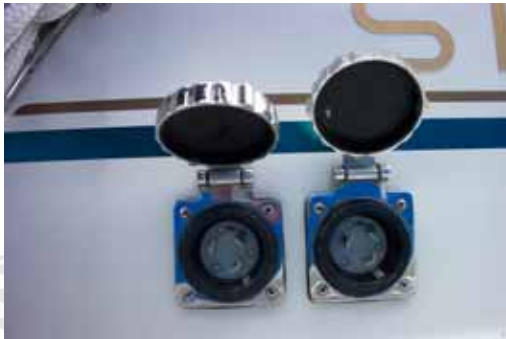
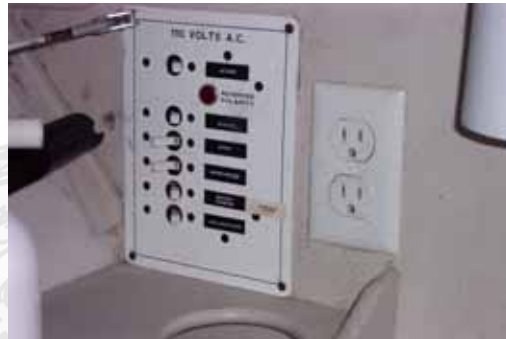
**SHORE POWER INLET**

There are dual 30 amp Marinc power inlets on starboard side of house. They are clean, corrosion free and show no arcing burns on terminals. The boat has 2-30 amp circuits with air conditioning and cook stove fed by to forward inlet and the remainder branches fed by the aft inlet. Most of the branches including the battery charger are on the aft inlet circuit.
